NPIC/R-683/64 August 1964

PHOTOGRAPHIC INTERPRETATION REPORT

# ICBM COMPLEX, ZHANGIZ-TOBE, USSR

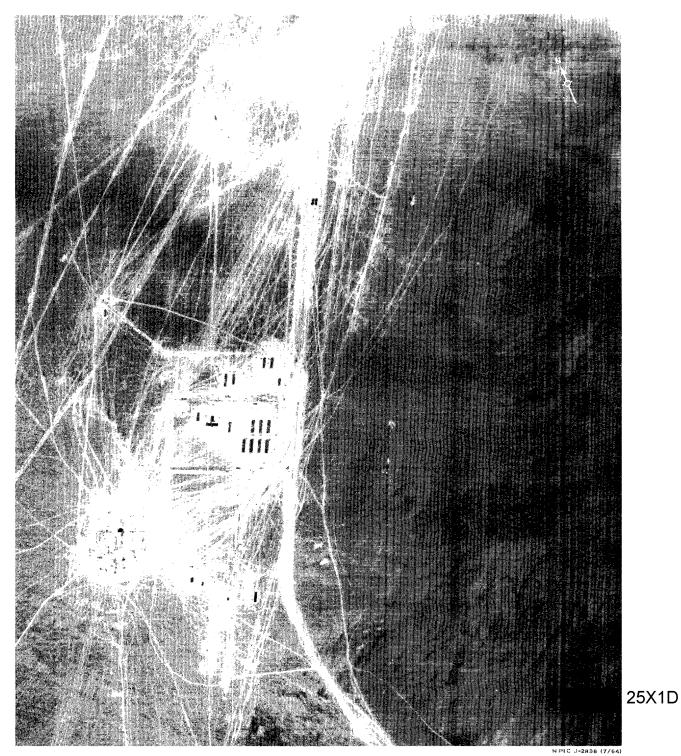
FIGURE 2. COMPLEX SUPPORT FACILITY.

The complex support facility (49-12N 81-10E) is 1.8 nm west of Zhangiz-Tobe, at the eastern end of the complex. It is served by a spur from the rail line between Semipalatinsk and Alma-Ata, and also has road connections with the highway between the two cities. The facility (Figures 2 and 3) is still under construction, and consists of a probable railhead and storage area, a probable administration and housing area, and a probable housing area. The probable railhead and storage area contains a long and a short rail siding, four completed buildings, and about nine more buildings under construction. To the east of it is the probable administration and housing area containing about 34 buildings which appear to be completed. Eighteen of these buildings, in an area about 1,380 feet long and 940 feet wide, are enclosed by a fence. Ditching is discernible around two sides of the fence. Part of the ditching extends 1,100 feet northeast

to an isolated building and some scattered equipment. The probable housing area, containing eight buildings, is north of the probable railhead and storage area.

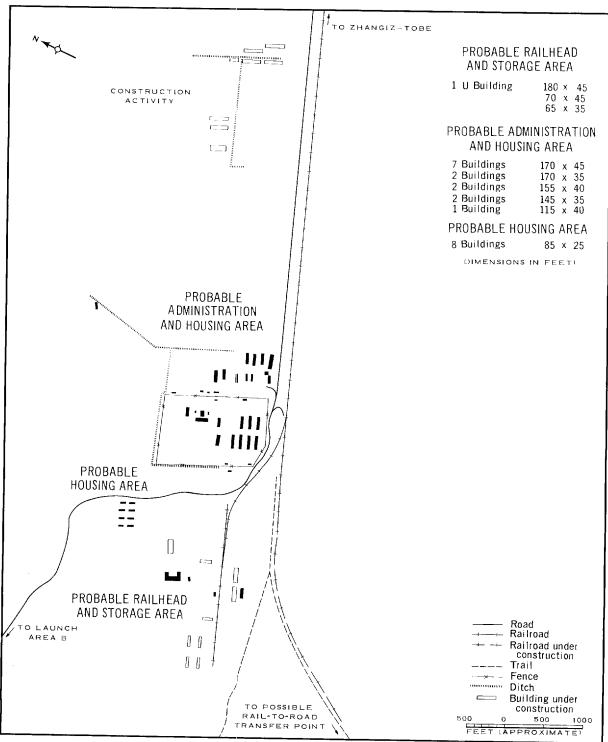
FIGURE 3. LAYOUT OF COMPLEX SUPPORT FACILITY.

Construction activity can be observed in an area about 3,000 feet east of the complex support facility. Eight building foundations, the largest 250 by 50 feet, and considerable ditching are identifiable. This activity probably is associated with the complex support facility.

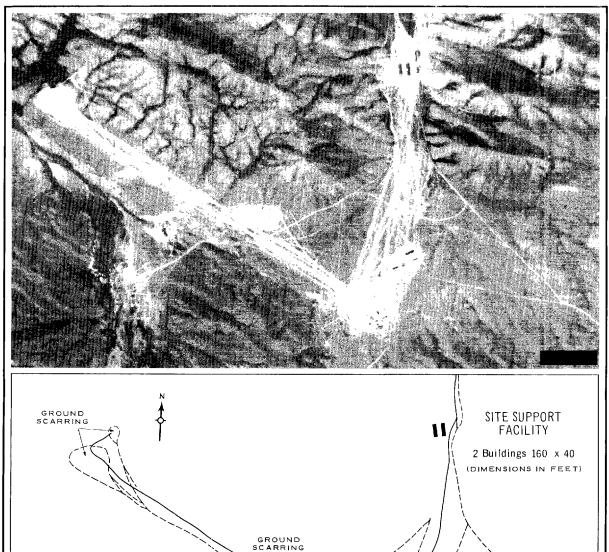
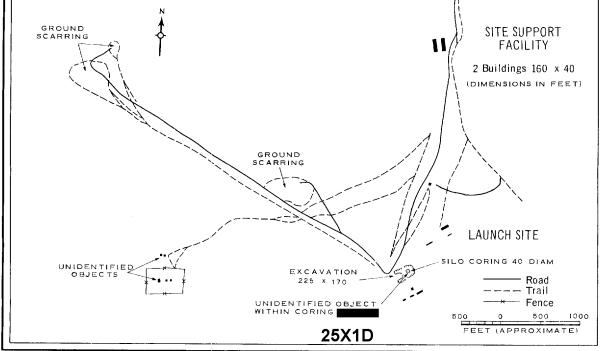
FIGURE 4. LAUNCH AREA A.

Launch Area A consists of a Type IIIC launch site and a site support facility (Figure 4). It is 6.3 nm west-southwest of the complex support facility in a small valley. The launch area was in a very early stage of construction in

The launch site was still in an early stage of construction in

It contains an excavation with two ramps leading into it. The coring for a single silo is under construction within the excavation. An unidentified object is discernible within the silo coring. Seven buildings of various sizes

and some equipment also can be identified within the site. No security fencing is apparent.

The site support facility is 2,500 feet north of the launch site. It contains only two buildings and several pieces of equipment.

A fenced area, which measures 465 by 330 feet and contains three small unidentified objects, is 2,500 feet west of the launch site. Two other small unidentified objects are outside the fencing. There are areas of ground scarring 1,500 and 4,500 feet northwest of the launch site.

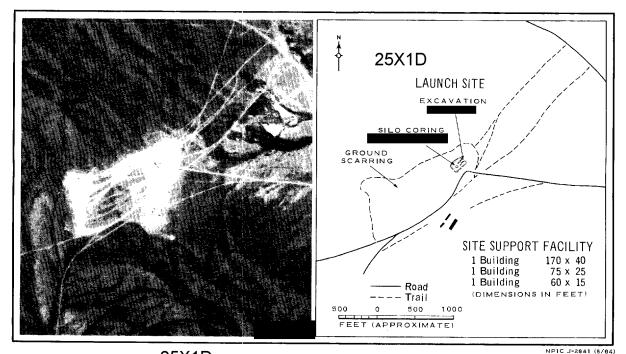
FIGURE 5. LAUNCH AREA B.

launch site and a site support facility (Figure 5). It is 8.2 nm northwest of the complex support facility in a saddle between two hills. The launch area was first observed in

Launch Area B consists of a Type IIIC

The launch site was in an early stage of construction in . An excavation with two ramps leading into it is

visible within the site. Work appears to have been started on the silo coring within the excavation, which also contains three unidentified objects or pieces of equipment. No security fencing is apparent.

The site support facility is 700 feet south of the launch site. It contains only three buildings. There is considerable ground scarring 1,100 feet northwest of the site support facility.
